## **FIBERGLASS-REINFORCED PLASTIC (FRP) PERFORMANCE UNDER THERMAL UPSET CONDITIONS**

Don Kelley  
Ashland Composite Polymers  
5200 Blazer Parkway  
Dublin, OH 43017

### **ABSTRACT**

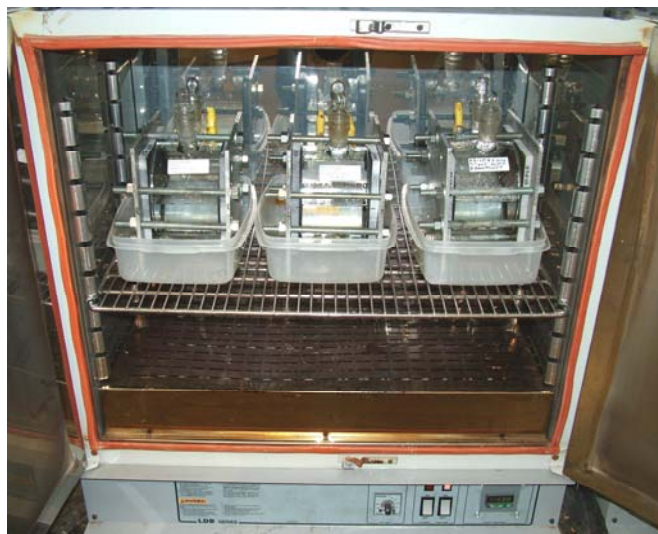
**FIGURE 2 - Atlas test cell placement in oven.**

The laminate samples were placed on each end of an Atlas Test Cell, as shown in Figure 1. The cells were filled half full with a deionized water solution containing 1500 ppm sulfuric acid, 250 ppm sulfurous acid, and 250 ppm hydrochloric acid. The cells were then placed in an oven, shown in Figure 2, at 65°C for a given period of time. For the c-veil only laminates, the oven time was 3 weeks. For the carbon/c-veil laminates, the oven time was 12 weeks.

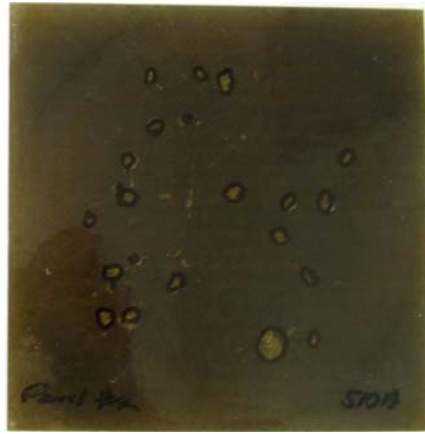
**FIGURE 7 – Br EVER FRP laminate with a carbon and c-glass veil exposed to test solution for 12 weeks and 1 hour at 204°C**

Figures 6 and 7 show the 12 week results of thermally shocking the brominated epoxy vinyl ester resin laminates with both carbon veil and c-glass veil at 182°C and 204°C respectively.

The brominated epoxy vinyl ester resin laminate had moderate blistering upon exposure to 204°C air for 1 hour. The laminate exposed at 182°C had slight blistering.

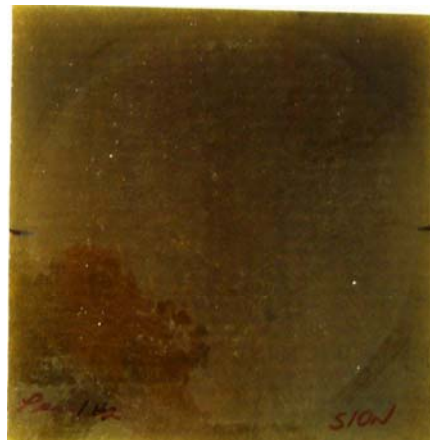
**FIGURE 8 – Br NEVER FRP laminate with carbon and c-glass veil exposed to test solution for 24 weeks and 1 hour at 182°C**

Figures 8 and 9 show the 24 week results of thermally shocking the brominated novolac epoxy vinyl ester resin laminates with carbon and c-glass veil at 182°C and 204°C respectively.

After 24 weeks in the 65°C test cell, the brominated novolac epoxy vinyl ester resin laminate did not blister upon exposure for 1 hour at either 182°C or 204°C.

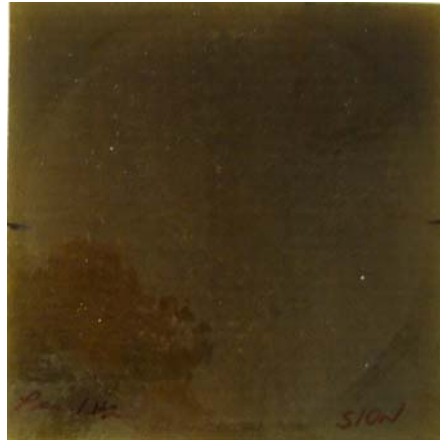
**FIGURE 9 – Br NEVER FRP laminate with carbon and c-glass veil exposed to test solution for 24 weeks and 1 hour at 204°C**

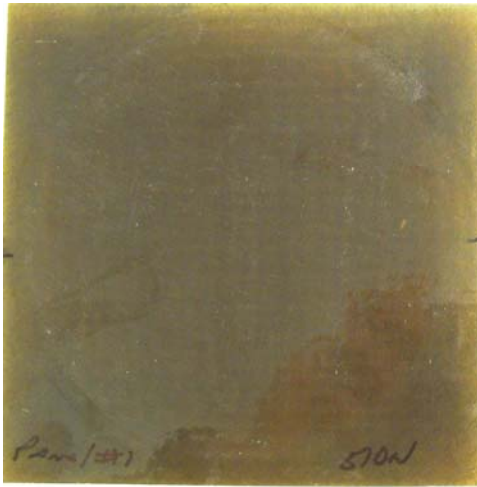
**FIGURE 11 – Br NEVER FRP laminate with carbon and c-glass veil exposed to test solution for 36 weeks and 1 hour at 182°C**

Figures 11 and 12 show the results of the respective exposure of the brominated novolac epoxy vinyl ester resin laminates that were exposed to 182°C and 204°C after 36 weeks in the test cell.

In this case, the laminate exposed to 204°C air for 1 hour blistered, but the laminate exposed to 182°C air did not blister.

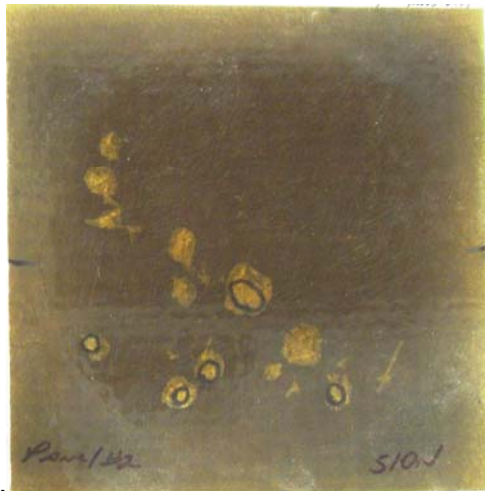
**FIGURE 12 – Br NEVER FRP laminate with carbon and c-glass veil exposed to test solution for 36 weeks and 1 hour at 204°C**
